SHEDDING SOME LIGHT ON THIS THING CALLED RISK ASSESSMENT

Part II Example Risk Analysis

BY GREGG A. SCOTT, P.E. AND WILLIAM F. FIEDLER, P.E.

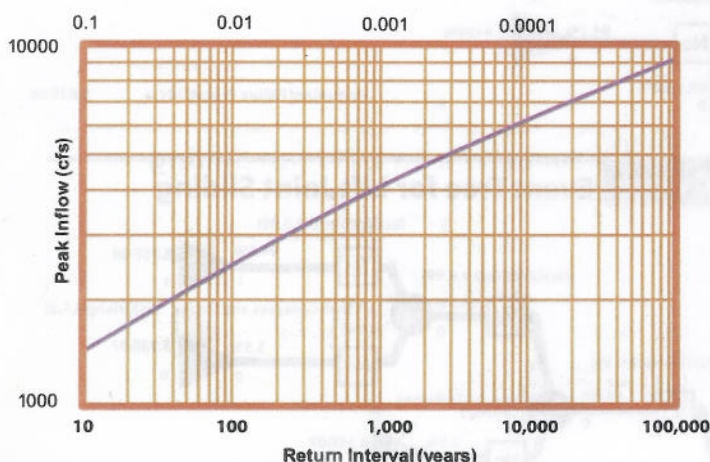
**FIGURE 4 Flood Frequency Analysis
Mean Annual Exceedance Probability**

Ideally maximum reservoir elevations during floods would be determined by routing frequency floods. In this example, a flood frequency analysis has been conducted and the information is provided in Figure 4. A flood routing study has not been performed. However, the reservoir capacity is relatively small with little in the way of flood control storage in comparison to the size of the contributing watershed and the corresponding volume of flood runoff. Therefore, it was reasonable to assume that the reservoir provides no attenuation of peak reservoir inflow. Inflows defined by the discharge flood hazard curve (Figure 4) would therefore need to be passed through the project such that outflow is equal to inflow. The spillway discharge curve (Figure 5) could therefore be combined

with the flood hazard curve (Figure 4) to estimate the flood load range probabilities corresponding to the reservoir water surface elevations in the risk estimation model. For example, at reservoir elevation 2466, the spillway discharge is about 7,800 ft³/s, which corresponds to an annual flood exceedance probability of about 0.000025 from Figure 4. Similarly, at reservoir elevation 2467, the spillway discharge is about 9,300 ft³/s, which corresponds to a flood exceedance probability of about 0.000008 from Figure 4. Subtracting the two probabilities, results in a load range probability (for reservoir elevation 2466 to 2467) of 0.000017. The remaining load range probabilities defined by the event trees were similarly calculated. In the case of the upper overtopping load range, an exceedance probability of essentially zero (representing an upper bound flood that is several orders of magnitude more remote) is subtracted from the exceedance probability at reservoir elevation 2467.

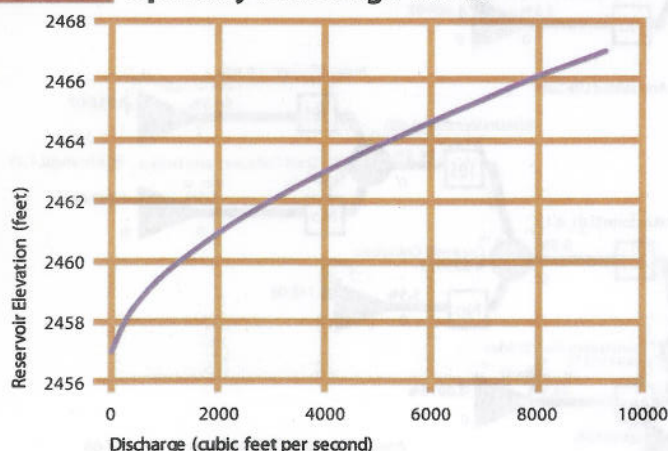
FIGURE 5 Spillway Discharge Curve

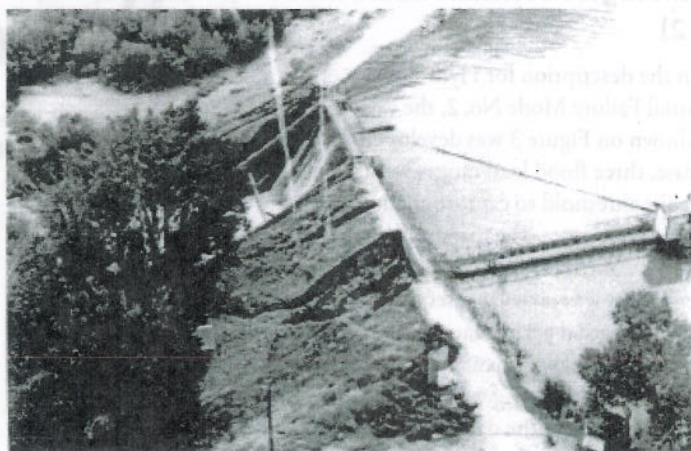
FIGURE 6 Nearby Dam after Overtopping

much smaller spillway capacity, overtopped by just over an inch. The duration of overtopping was unclear, but thought to be short. Although the dam did not fail, several large holes were eroded in the downstream face of the dam, and the corewall was exposed (see Figure 6). After discussion by the risk analysis team, it was concluded that due to the erodible nature of the fill and the experience afforded by the nearby dam overtopping, the downstream embankment would likely be completely eroded if overtopped for several hours by even just a few inches. Once the downstream fill was gone, the team concluded there would be very little chance of the core wall standing, and if the corewall failed, the upstream embankment was almost certain to collapse. Therefore, only one load range corresponding to overtopping was used. The "Yes" branch of each event node associated with overtopping (Downstream Shell Erodes, Corewall Collapses, and Upstream Shell Collapses and Erodes) was considered to be Very Likely (0.9) to Virtually Certain (0.99) using the verbal descriptor transformations in Table 1. This probability was defined using a

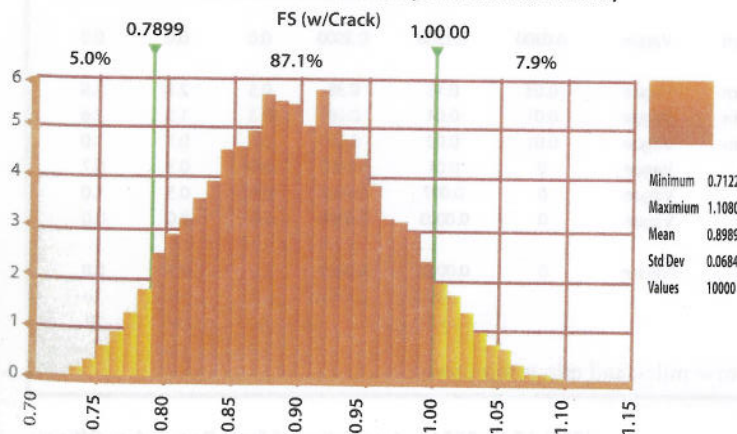
FIGURE 8 FS output Distribution Lift Joint Sliding for Reservoir Elevation 2466-2467 (horizontal axis is FS)

A Monte-Carlo analysis with 10,000 iterations was performed using the analysis spreadsheet and input distributions. The load ranges and probability of each load range is already accounted for in the first node of the event tree. The probability of exceeding the concrete tensile strength for each load range is estimated in the second node. The conditional failure probability,

given that the concrete tensile strength is exceeded, is needed for the third node at each load range. Therefore, a simulation was run for each load range. The probability of being at a given reservoir elevation within each load range varies and is less likely toward the upper end of the load range. For example, in the upper load range, reservoir elevation 2466 occurs three times more frequently than reservoir elevation 2467. A general distribution was set up to account for this, and the reservoir elevation was selected from this general distribution for each iteration in the spreadsheet Monte-Carlo calculations. A similar procedure was used for the other load ranges. The resulting output distribution of factor of safety (FS) is shown on Figure 8 for the upper load range (reservoir elevation 2466 to 2467). The Monte-Carlo results indicate about 92 percent of the calculated factors of safety are less than 1.0. Similar analyses indicate a probability of FS < 1.0 of 0.37 for the middle load range (reservoir elevation 2464 to 2466). None of the calculated factors of safety in the Monte-Carlo simulation were less than 1.0 for the lower load range (reservoir elevation 2462 to 2464). Therefore a different method, based on a term called the “reliability index”, was used to estimate the probability of safety factor less than 1.0. This method is not described in detail here. Those interested in further explanation of the method are referred to Scott (2007). This analysis resulted in an estimated probability of FS < 1.0 of about 0.0015 for the lower load range. Since the structure is relatively long compared to its height, three-dimensional influences would be limited and the probability of FS < 1.0 was taken as the conditional probability of failure for all load ranges.
